CORROSION TESTING IN LOW OXYGEN CONTENT BRINE

CAPCIS Ref. NA6970
Rev 1
September 2008

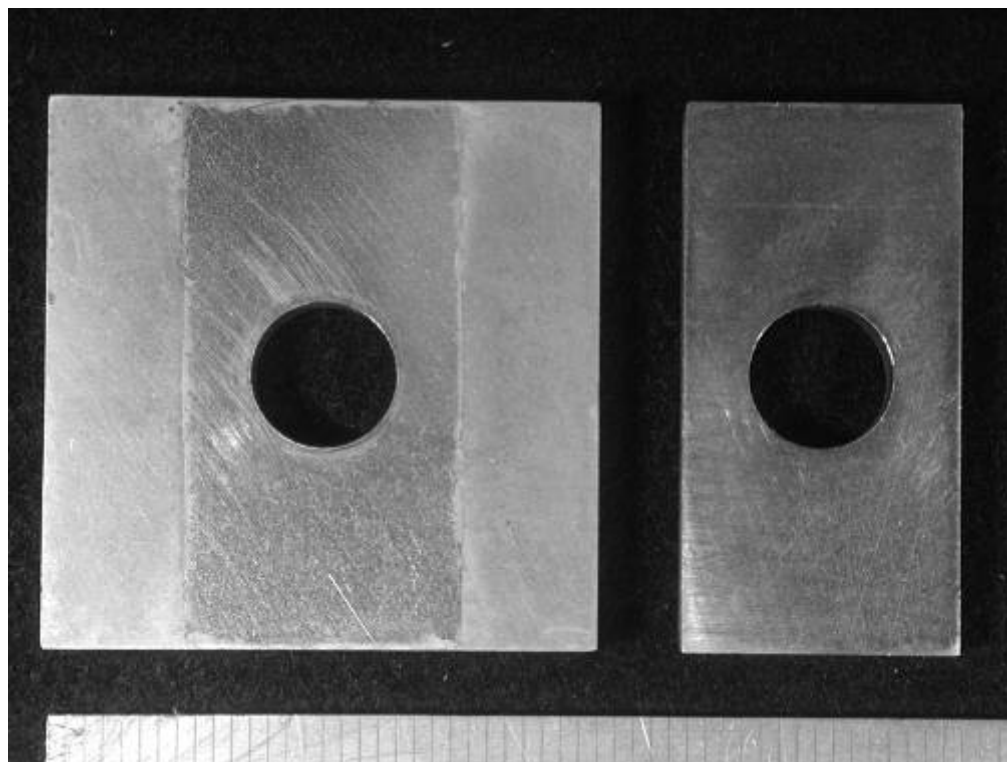
Figure 2. Hastelloy C276 coupons after test in 20 ppb O₂, before cleaning.

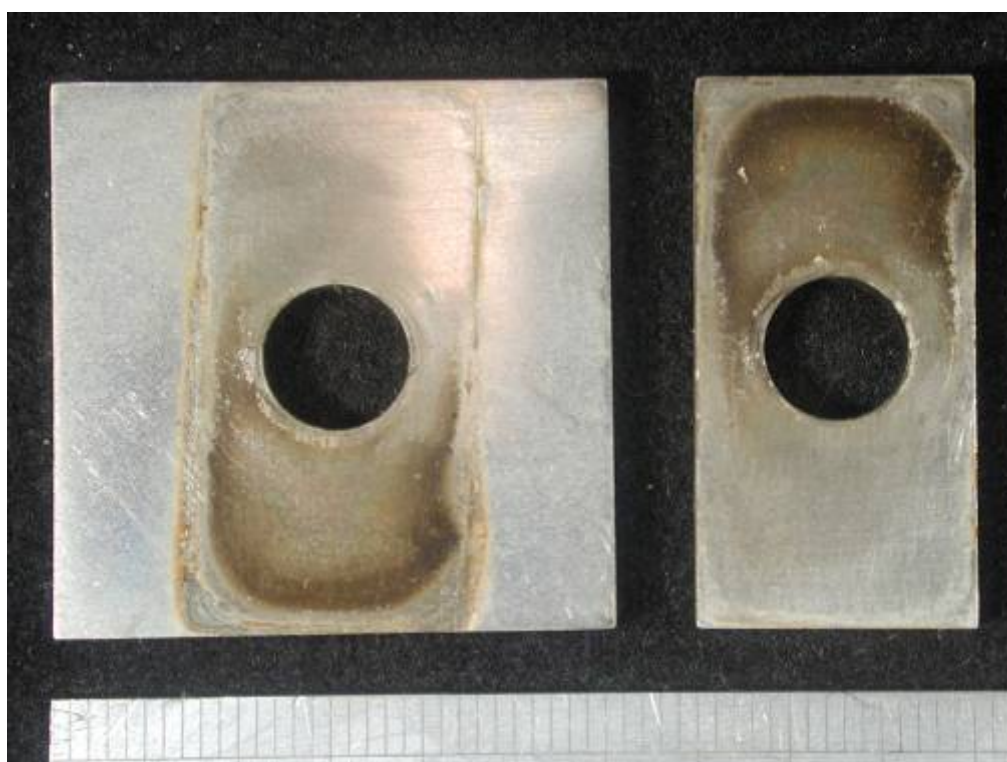
Figure 3. Hastelloy C276 coupons after test in 500 ppb O₂, before cleaning.

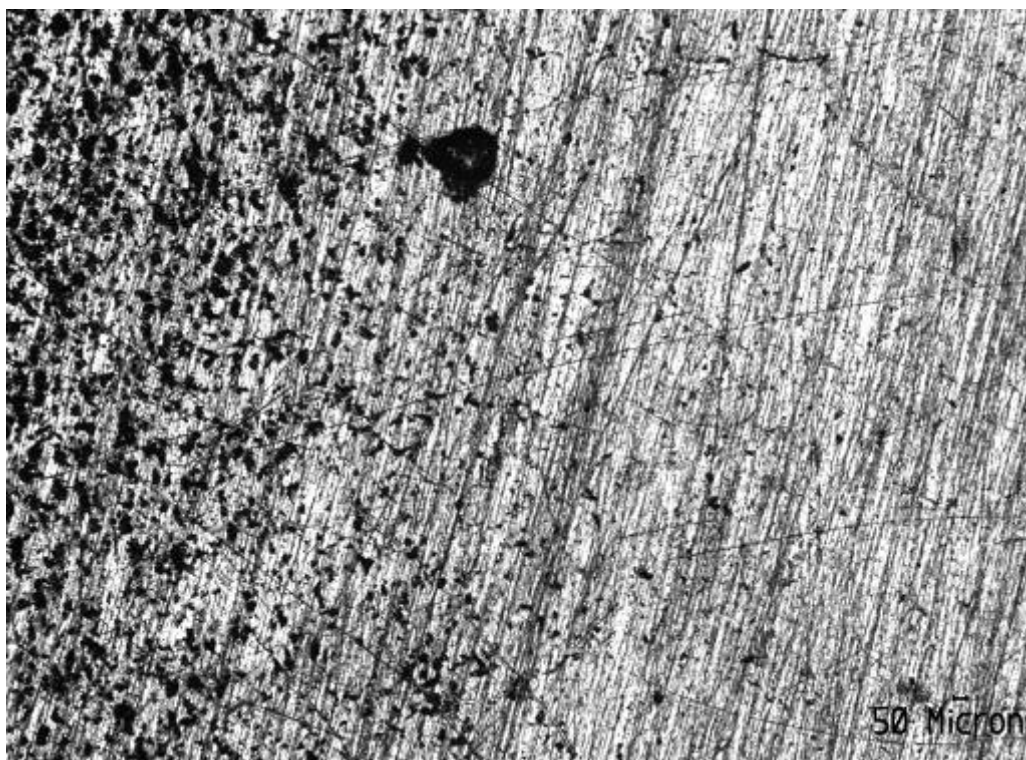
Slight corrosion attack had occurred within and away from the crevices. This was limited to $\sim 10 \mu\text{m}$ in the 20 and 500 ppb DO brines but was up to $\sim 40 \mu\text{m}$ in the 100 ppb DO brine. This ordering is not expected, but note that there is some degree of scatter in pitting and crevice corrosion processes.

Figure 4. Edge of creviced area on Hastelloy C276 coupon after cleaning.

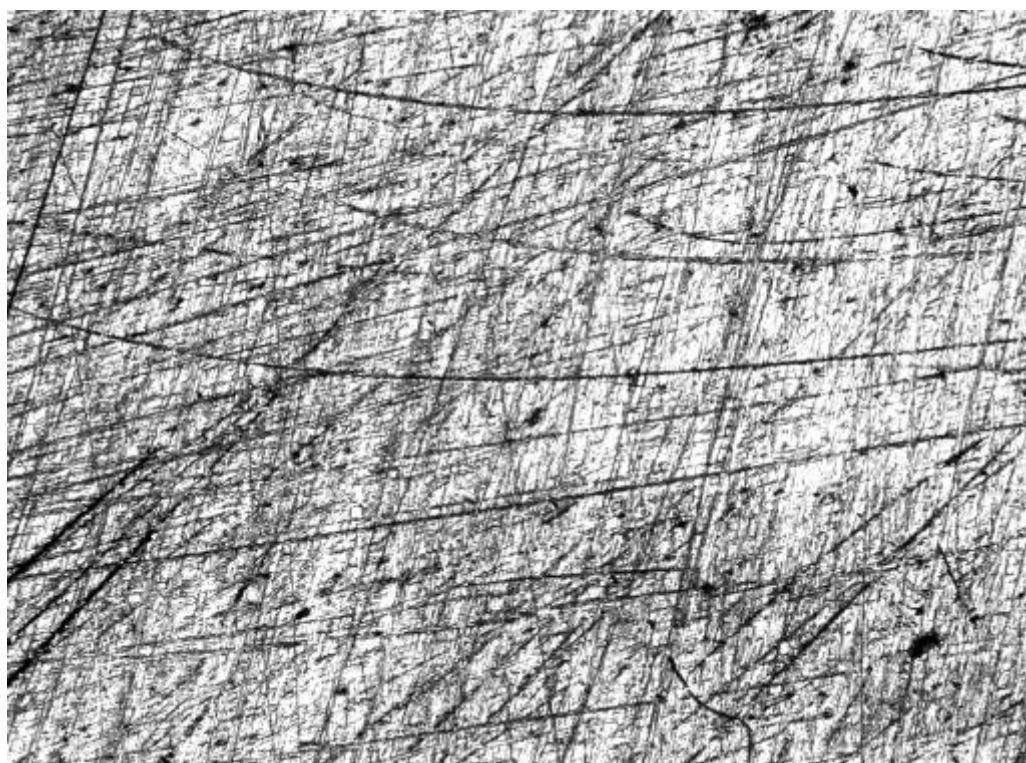
Figure 5. Non- creviced area on Hastelloy C276 coupon after cleaning.

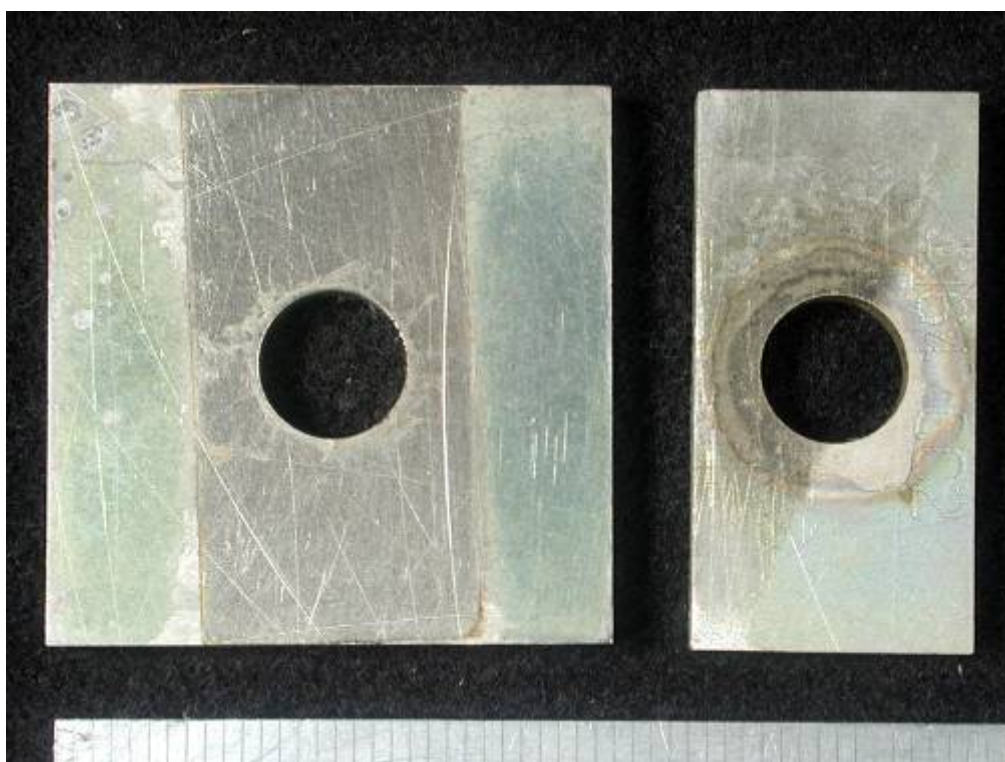
Figure 6. Cast Alloy 625 coupons after test in 20 ppb O₂, before cleaning.

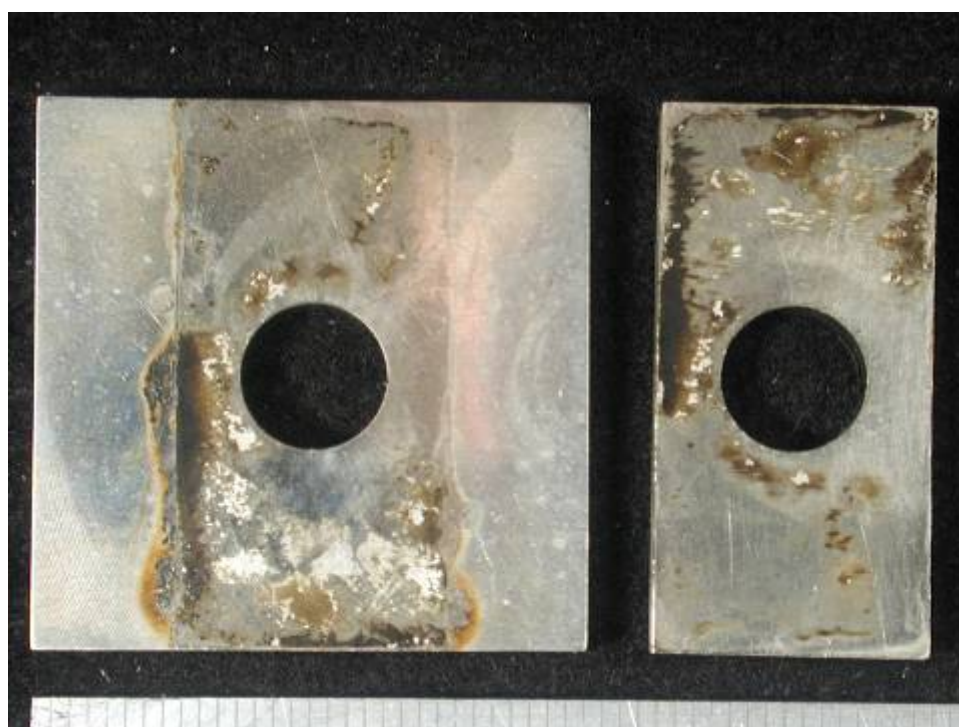
Localised corrosion was typically $< 5 \mu\text{m}$ in depth, but at the edge of the crevice in the 500 ppb containing oxygen test, an area of crevice corrosion to approximately 200 μm was identified.

Figure 7. Cast Alloy 625 coupons after test in 500 ppb O₂, before cleaning.

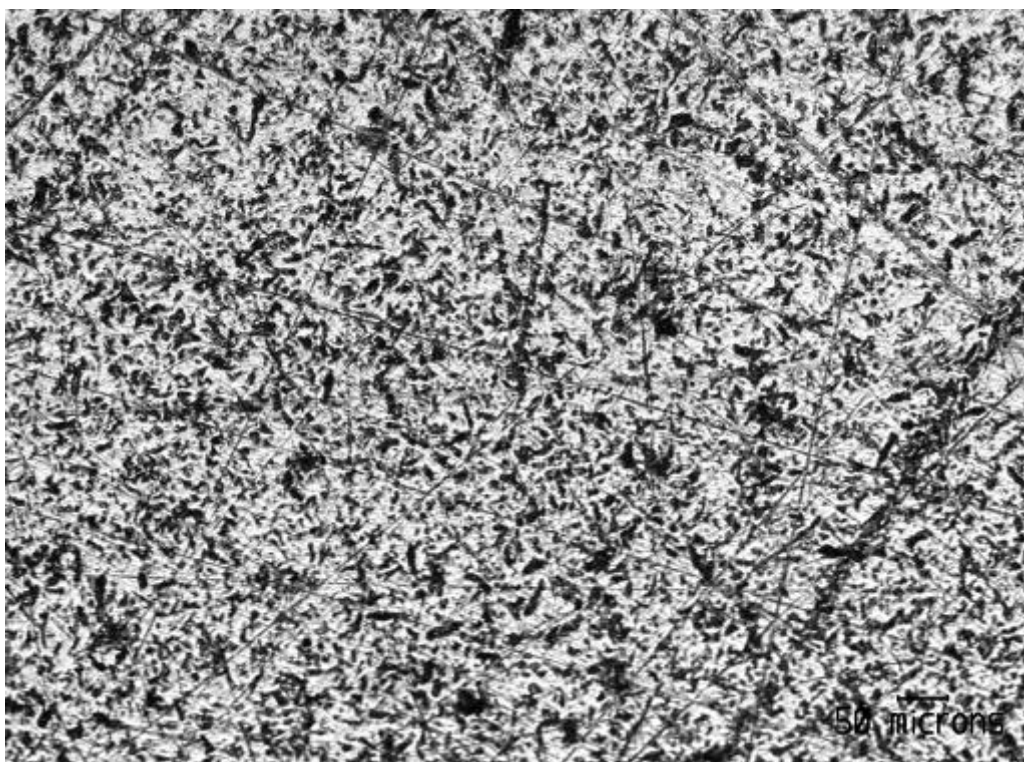
Figure 8. Creviced area on Alloy 625 coupon after cleaning.

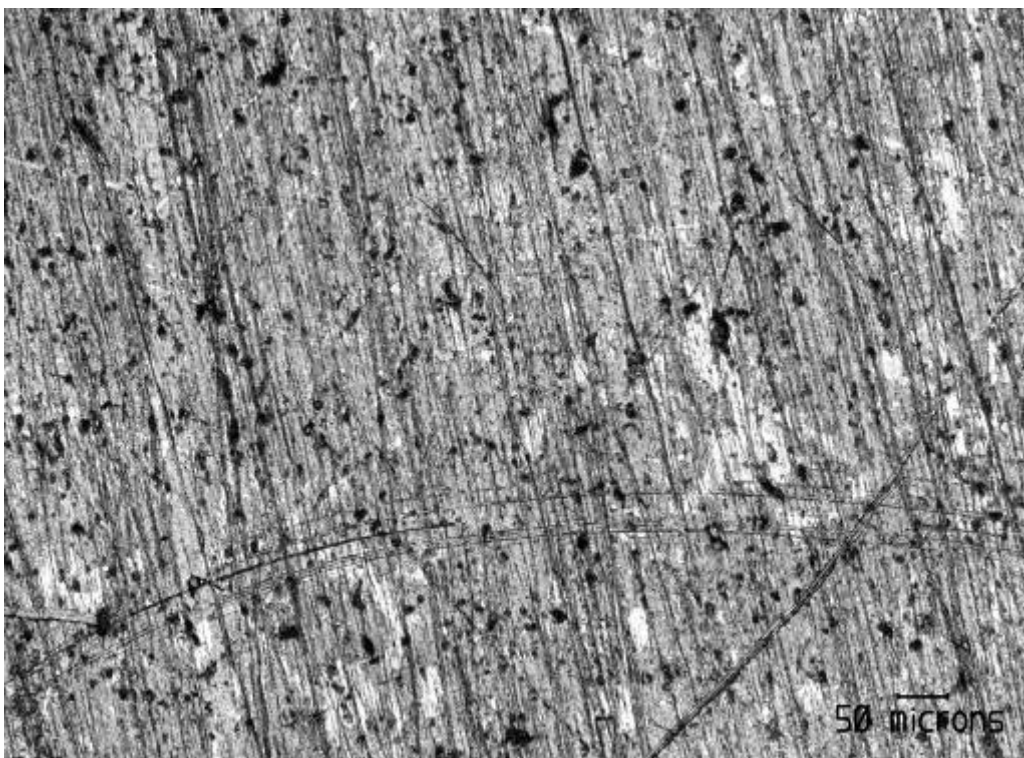
Figure 9. Non- creviced area on Alloy 625 coupon after cleaning.

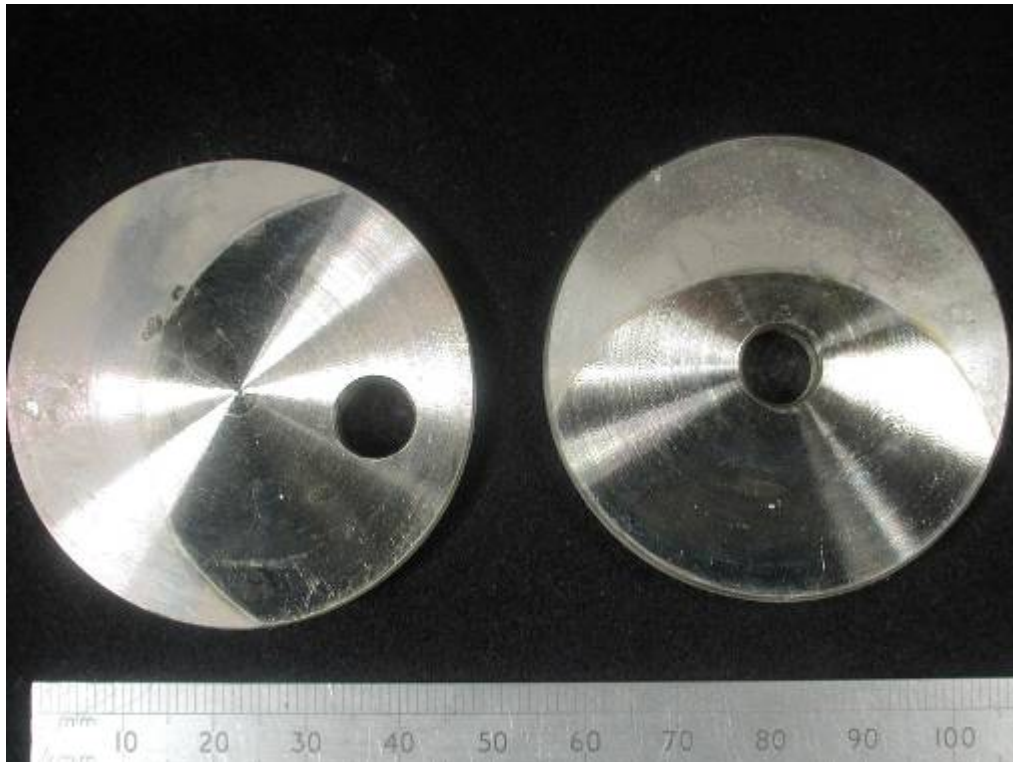
Figure 10. Zeron 100 coupons after test in 20 ppb O₂, before cleaning.

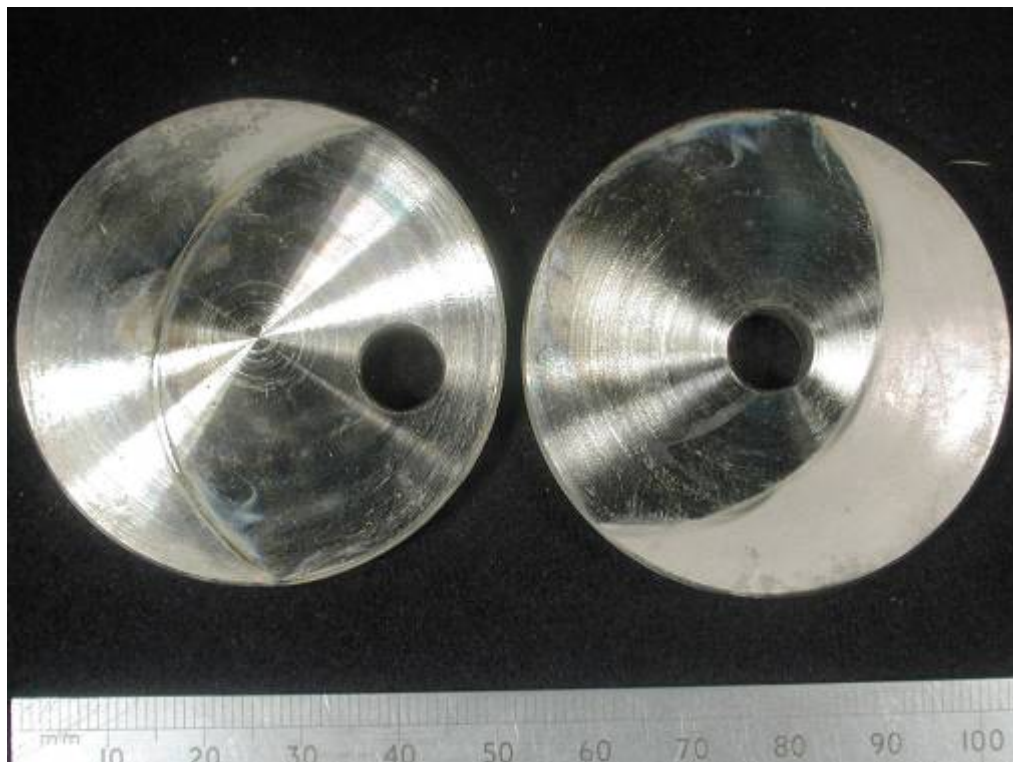
One area of crevice corrosion was identified on the rear of one coupon (at the PEEK contact point) in the 100 ppb DO test and depassivation had occurred on the other large coupon. Crevice corrosion had occurred in the 500 ppb DO test.

Figure 11. Zeron 100 coupons after test in 500 ppb O₂, before cleaning.

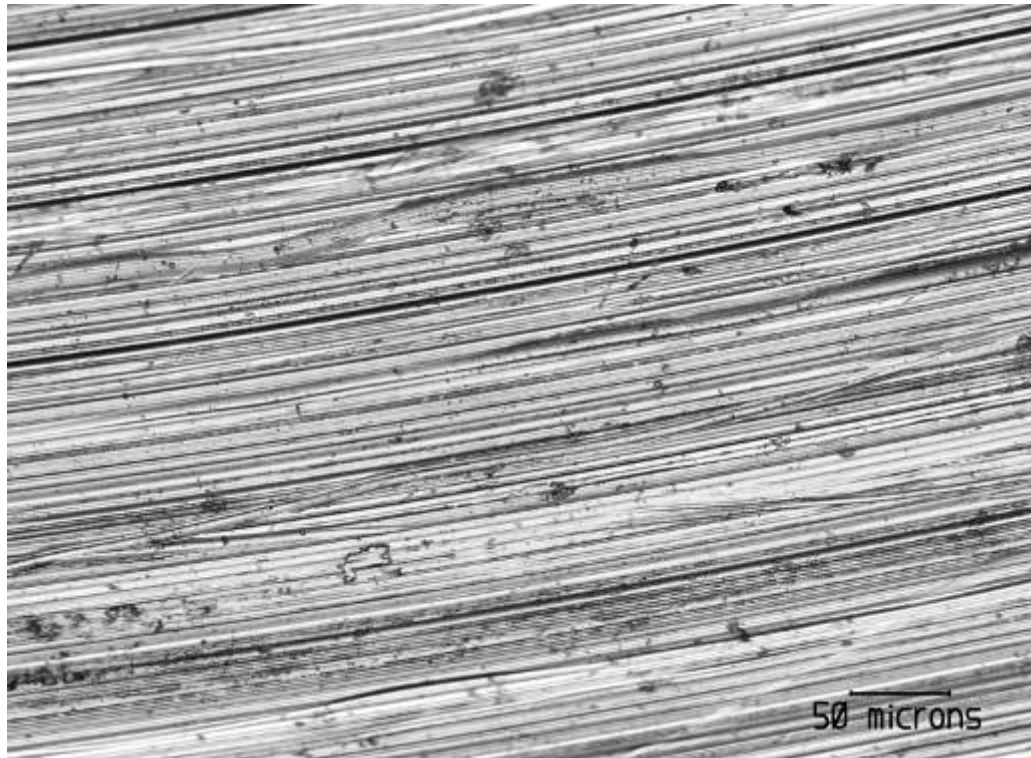
Figure 12. Creviced area on Zeron 100 coupon after cleaning.

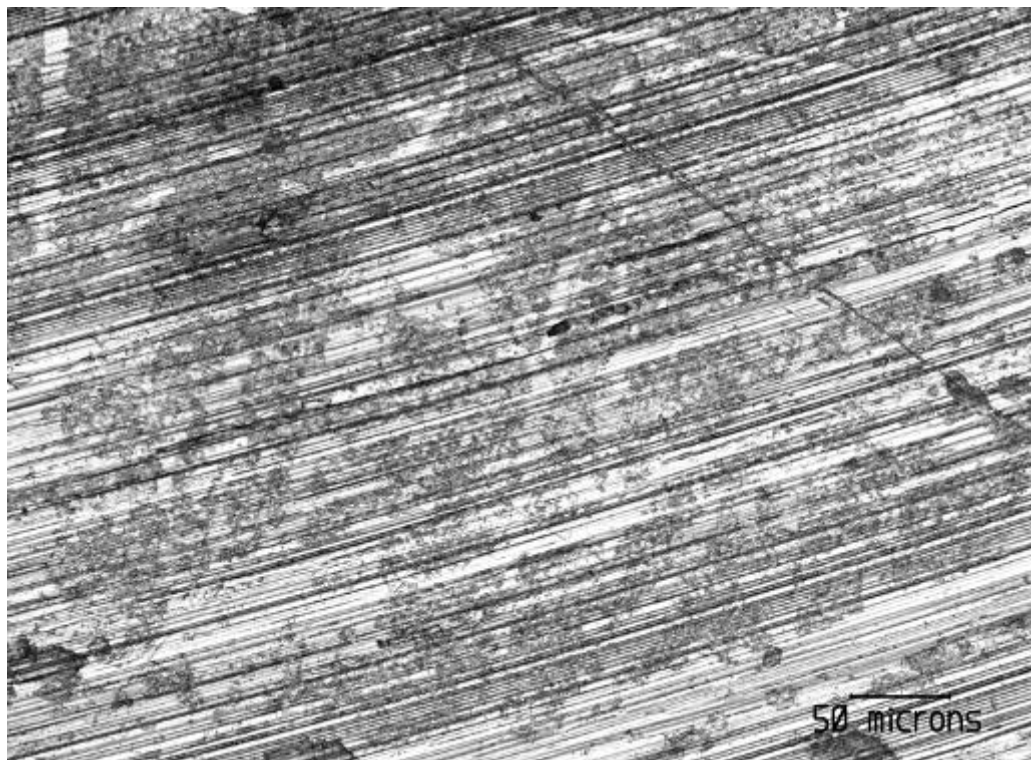
Figure 13. Non- creviced area on Zeron 100 coupon after cleaning.

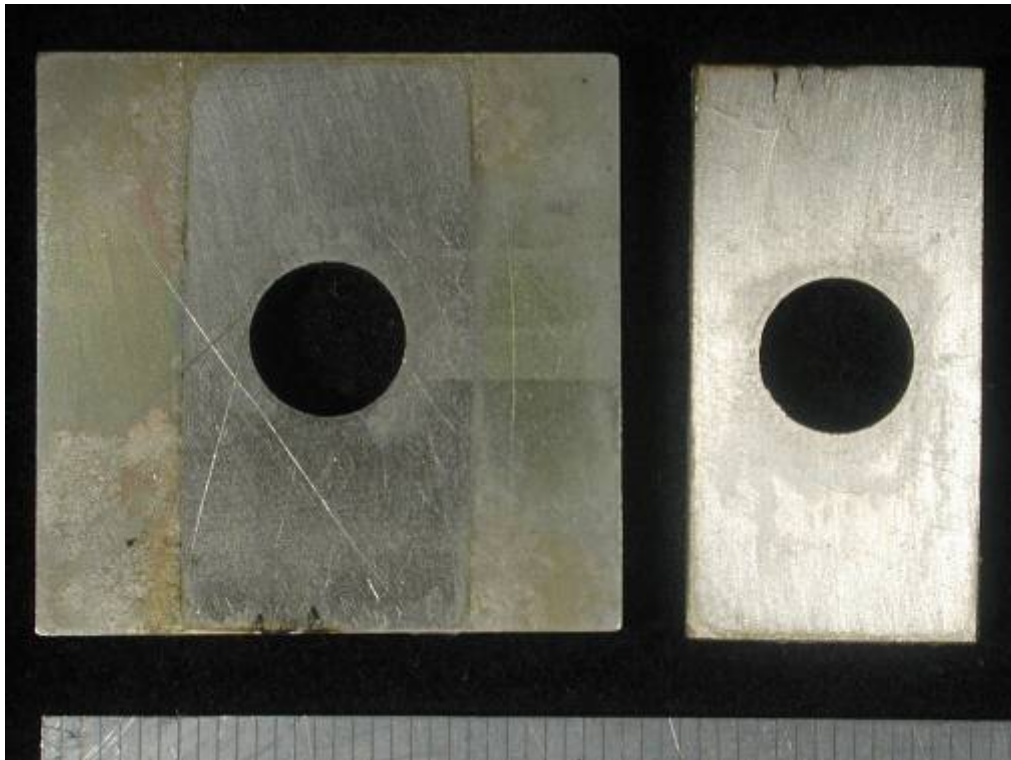
Figure 14. 6Mo coupons after test in 20 ppb O₂, before cleaning.

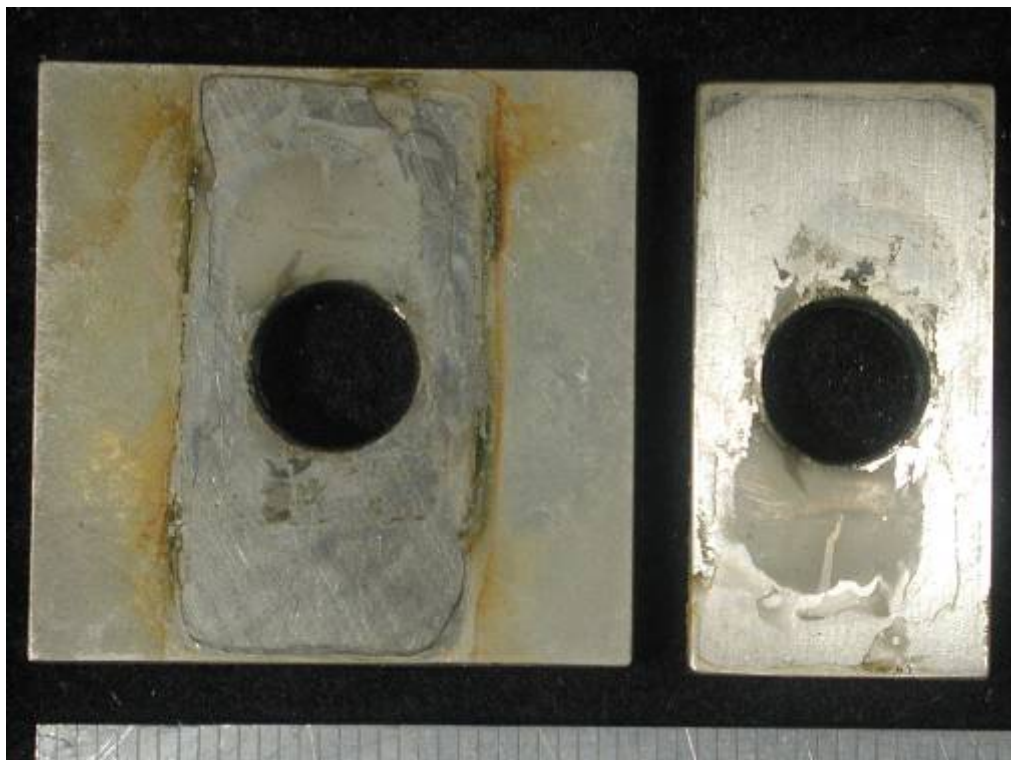
100 ppb DO attack was limited to a visual indication of depassivation at crevice sites plus pitting to <math><5\ \mu\text{m}</math> away from the crevices. At 500 ppb DO the depth of attack was approximately 400 μm within a crevice and pitting to a depth of <math><5\ \mu\text{m}</math> away from crevices.

Figure 15. 6Mo coupons after test in 500 ppb O₂, before cleaning.

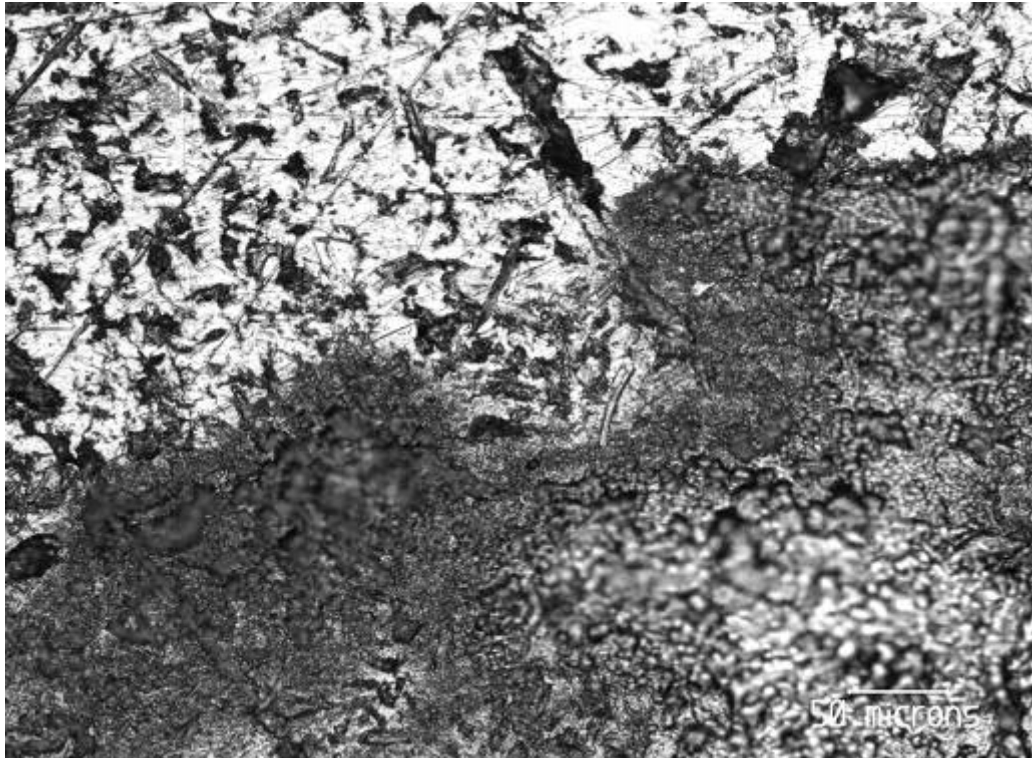
Figure 16. Creviced area on 6Mo coupon after cleaning.

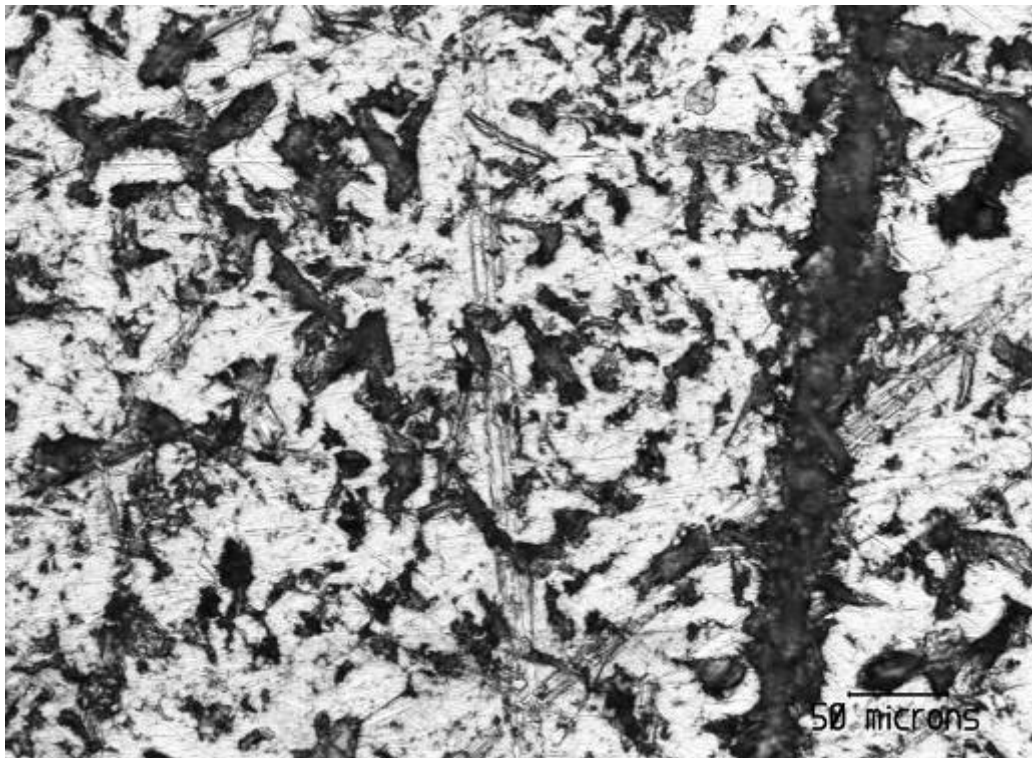
Figure 17. Non- creviced area on 6Mo coupon after cleaning.

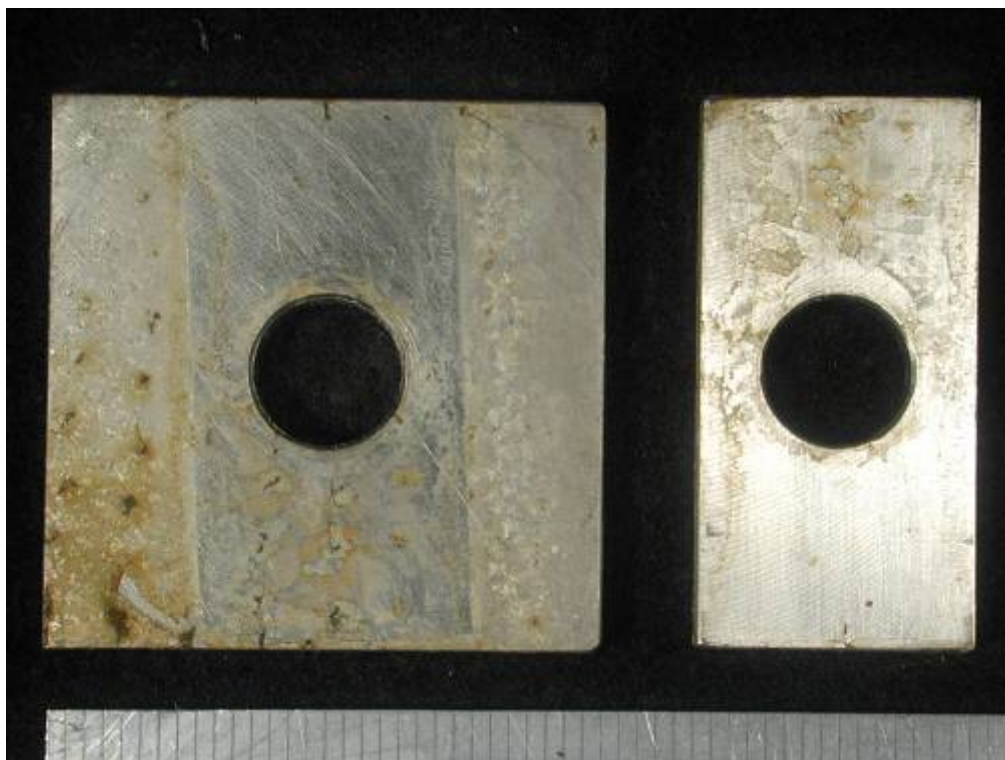
Figure 18. Welded Alloy 625 coupons after test in 20 ppb O₂, before cleaning.

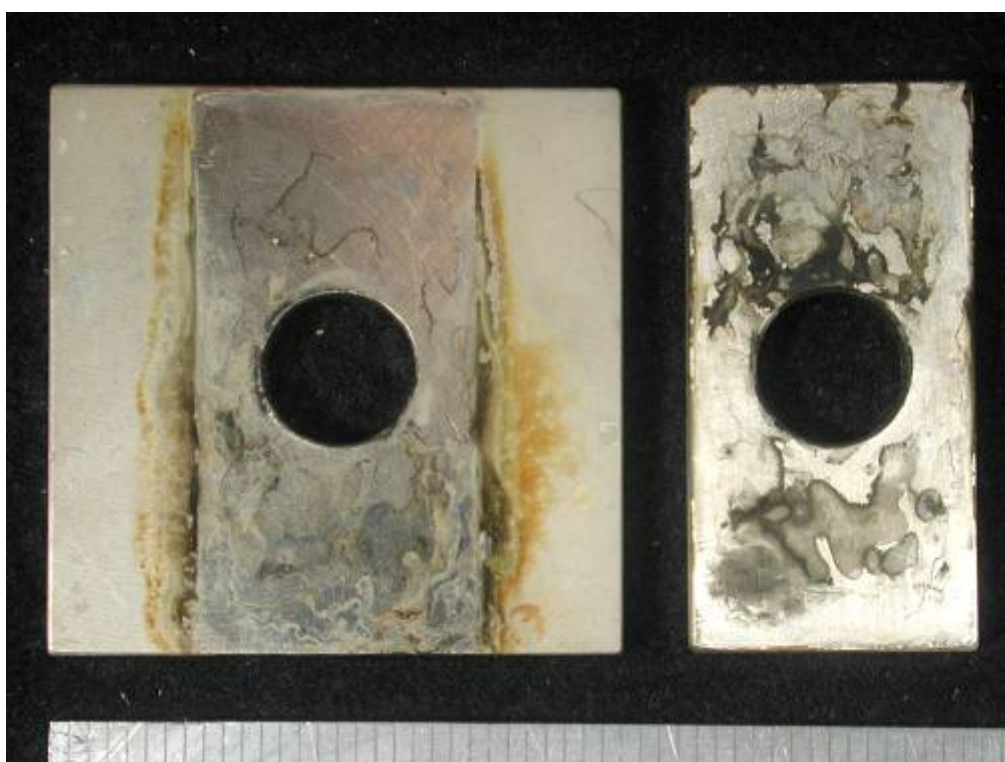
Figure 19. Welded Alloy 625 coupons after test in 500 ppb O₂, before cleaning.

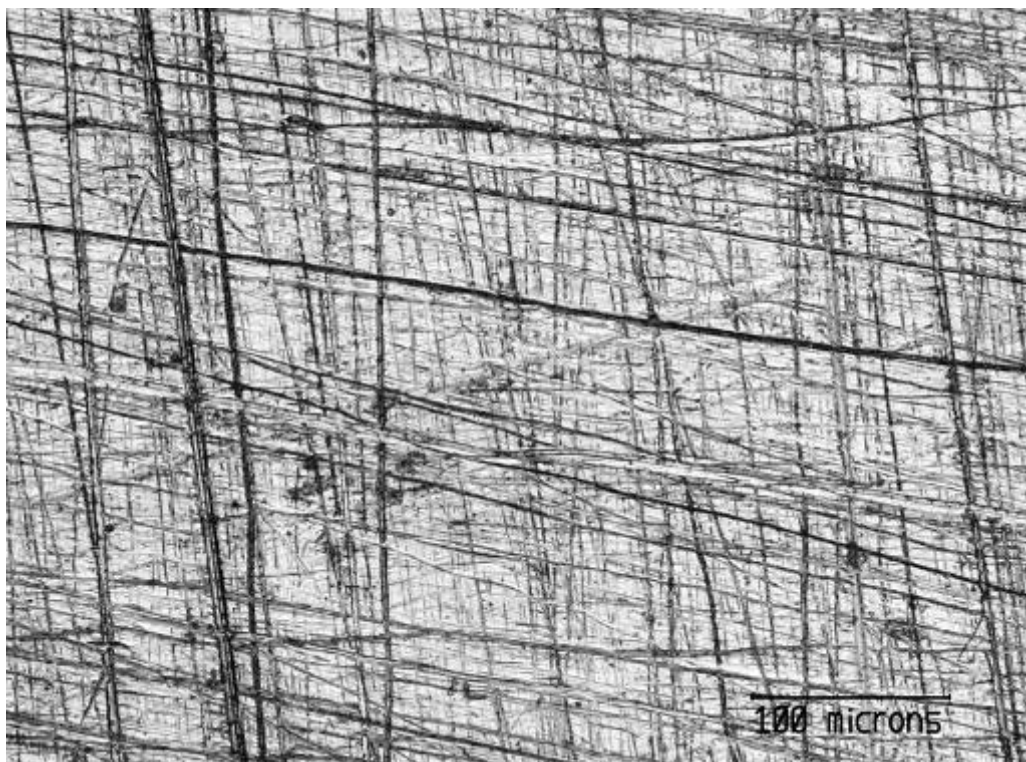
Figure 20. Creviced area on welded Alloy 625 coupon after cleaning.

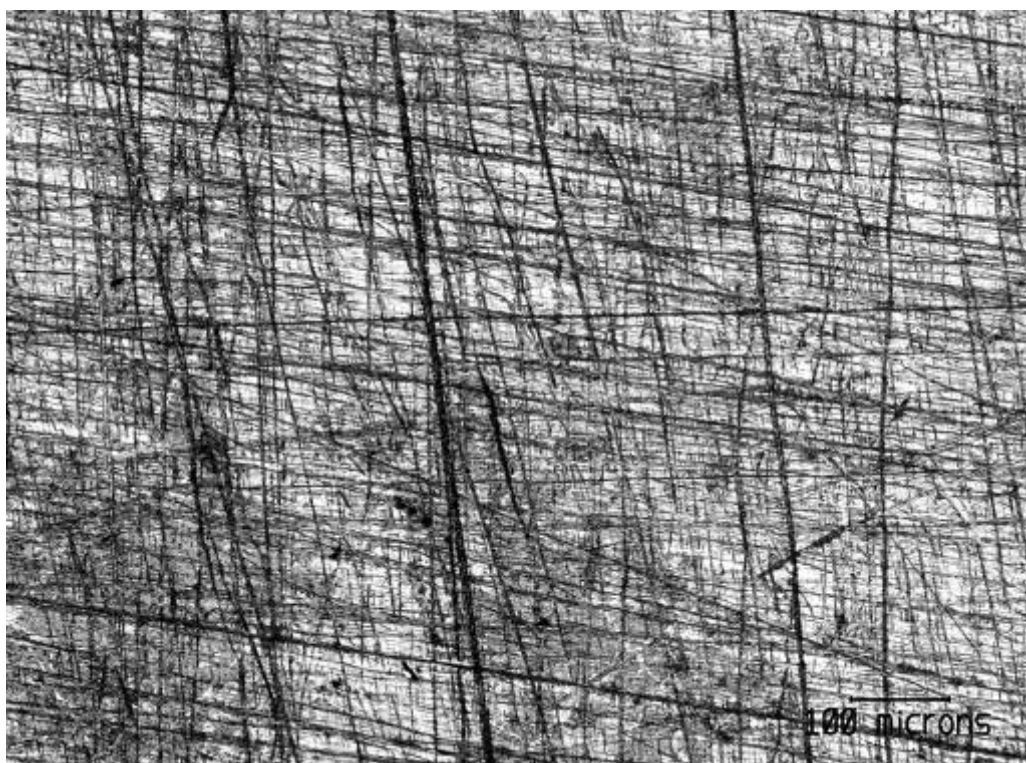
Figure 21. Non- creviced area on welded Alloy 625 coupon after cleaning.

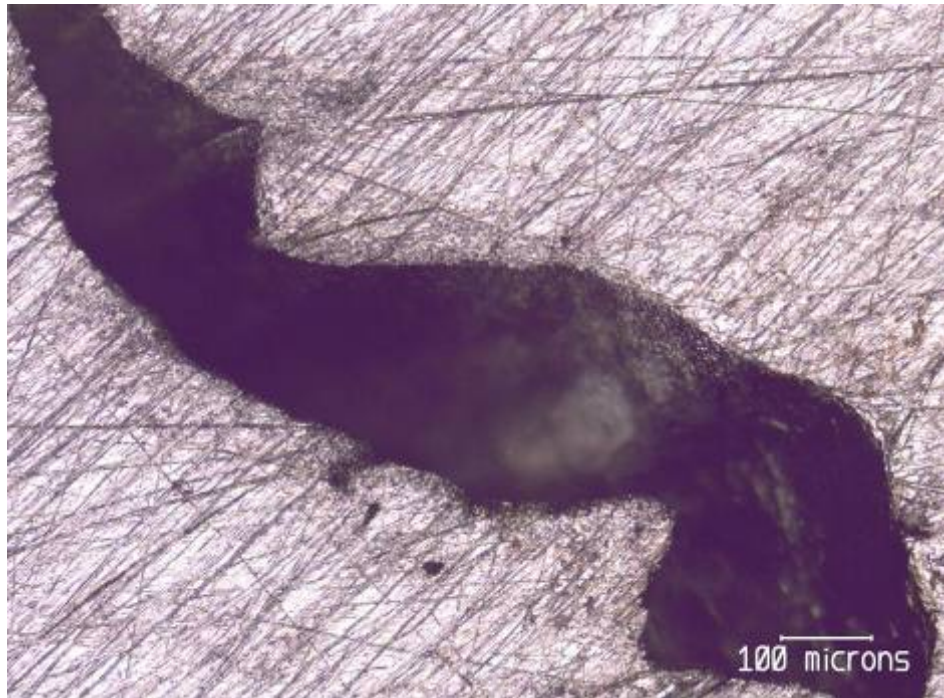
Cavities were present on one coupon at each temperature. These cavities appeared to be porosity or other weld-related features, and did not have the characteristics of localised corrosion attack. At 20 ppb DO the depth of the cavities ranged from 69-135 μm and were randomly distributed within and away from crevices. At 100 ppb DO attack was limited to a visual indication of depassivation at crevice sites plus shallow propagation. At 500 ppb DO the depth of cavities was in excess of 200 μm within and away from crevices and slight indications of crevice corrosion were also evident.

The pattern of the cavities suggested their origin was related to the deposition of the second layer of weld metal, but no metallurgical investigation was conducted to properly characterise them.

The welded Alloy 625 suffered significant weight loss, but the bulk of this was clearly related to the presence (or formation) of cavities. These cavities had the appearance of weld metal porosity, or perhaps slag inclusions dissolved during the exposure period. The cavities were present in only some of the coupons tested. The true extent of localised corrosion was limited to a few microns in depth, as would be expected in these test environments. Note that welding can significantly reduce the corrosion resistance of corrosion resistant alloys; this can occur simply due to alloying element segregation within the weld metal, it can be caused by loss of alloying elements (particularly Cr) during welding (especially if inert gas shielding is ineffective) and it can be caused by incorrect selection of welding consumable. However, the reason for the high weight losses recorded in these tests was the quality of the weld metal overlay; correctly deposited Alloy 625 would be expected to exhibit good resistance, as was evident away from the areas where cavities developed.

Figure 22. Cavity in welded Alloy 625 coupon.
