CORROSION TESTING IN LOW OXYGEN CONTENT BRINE

CAPCIS Ref. NA6970
Rev 1
September 2008

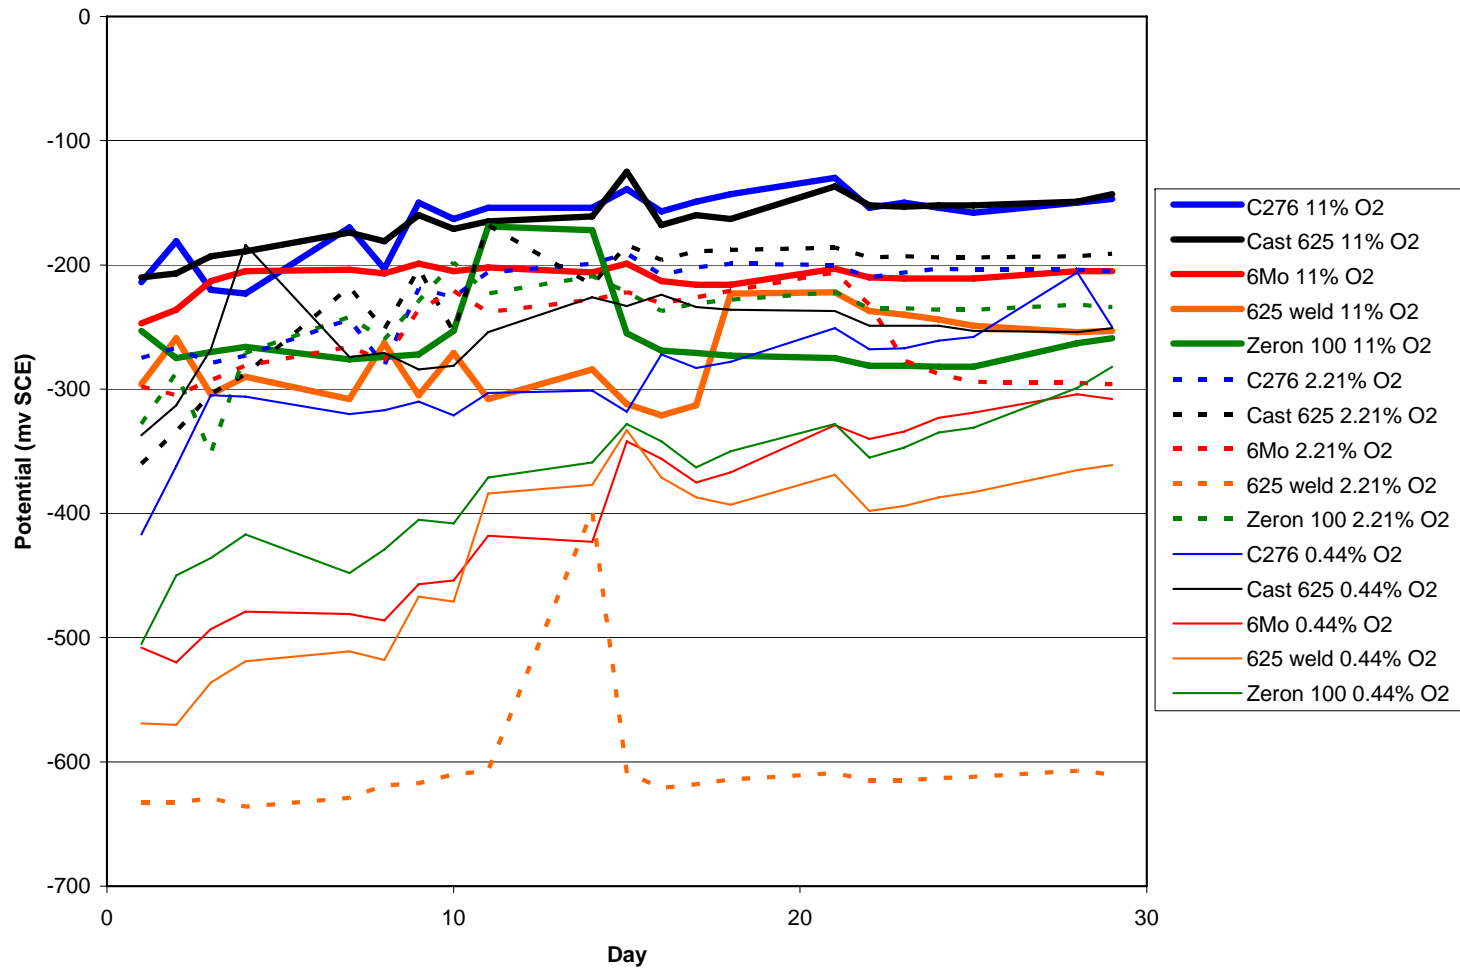
Figure 1. Potential measurements vs. SCE.

Potential measurements are presented in Figure 1. Note that an unidentified fault prevented the correct recording of the potential of the welded Alloy 625 in 2.21% oxygen conditions.
